## SB002

### Prevention of Piston Ring Land Fractures

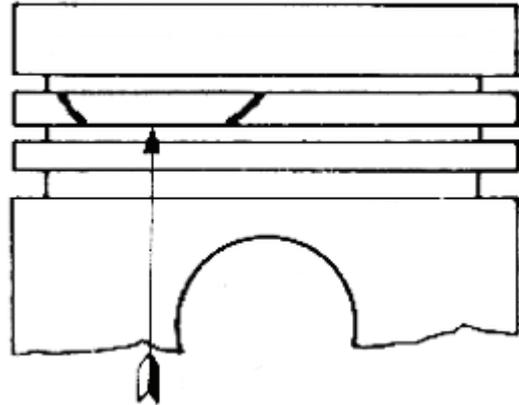
Figure 1

If the cracks or fracture lines are "V" shaped as in fig. 1, the damaging force must have come from the direction of the piston open end. The natural forces exerted on a piston from this direction are relatively small and could not cause land fracture. The most probable cause of this type of fracture would be an assembly problem which could cause the rings to contact the top of the cylinder. The extra pressure needed to try and push the piston into its cylinder would force the rings upwards on the piston and crack the lands. Piston ring gaps which foul cylinder ports in two stroke engines can also cause this type of damage.
